MAXIMUM ESTIMATED TSUNAMI INUNDATION, ORCA INLET, CORDOVA, ALASKA, 2022 UPDATE

DIVISION OF GEOLOGICAL & GEOPHYSICAL SURVEYS

D.J. Nicolsky¹, E.N. Suleimani¹, J.B. Salisbury² 2022 SCALE 1:14000 0 0.25 0.5 1 MILE 0 250 500 1000 METERS 0 500 1000 METERS ANCHORAGE VALDEZ MC CARTHY ANCHORAGE VALDEZ MC CARTHY ANCHORAGE VALDEZ MC CARTHY ANCHORAGE VALDEZ MC CARTHY BERING GLACIER OF DOVA

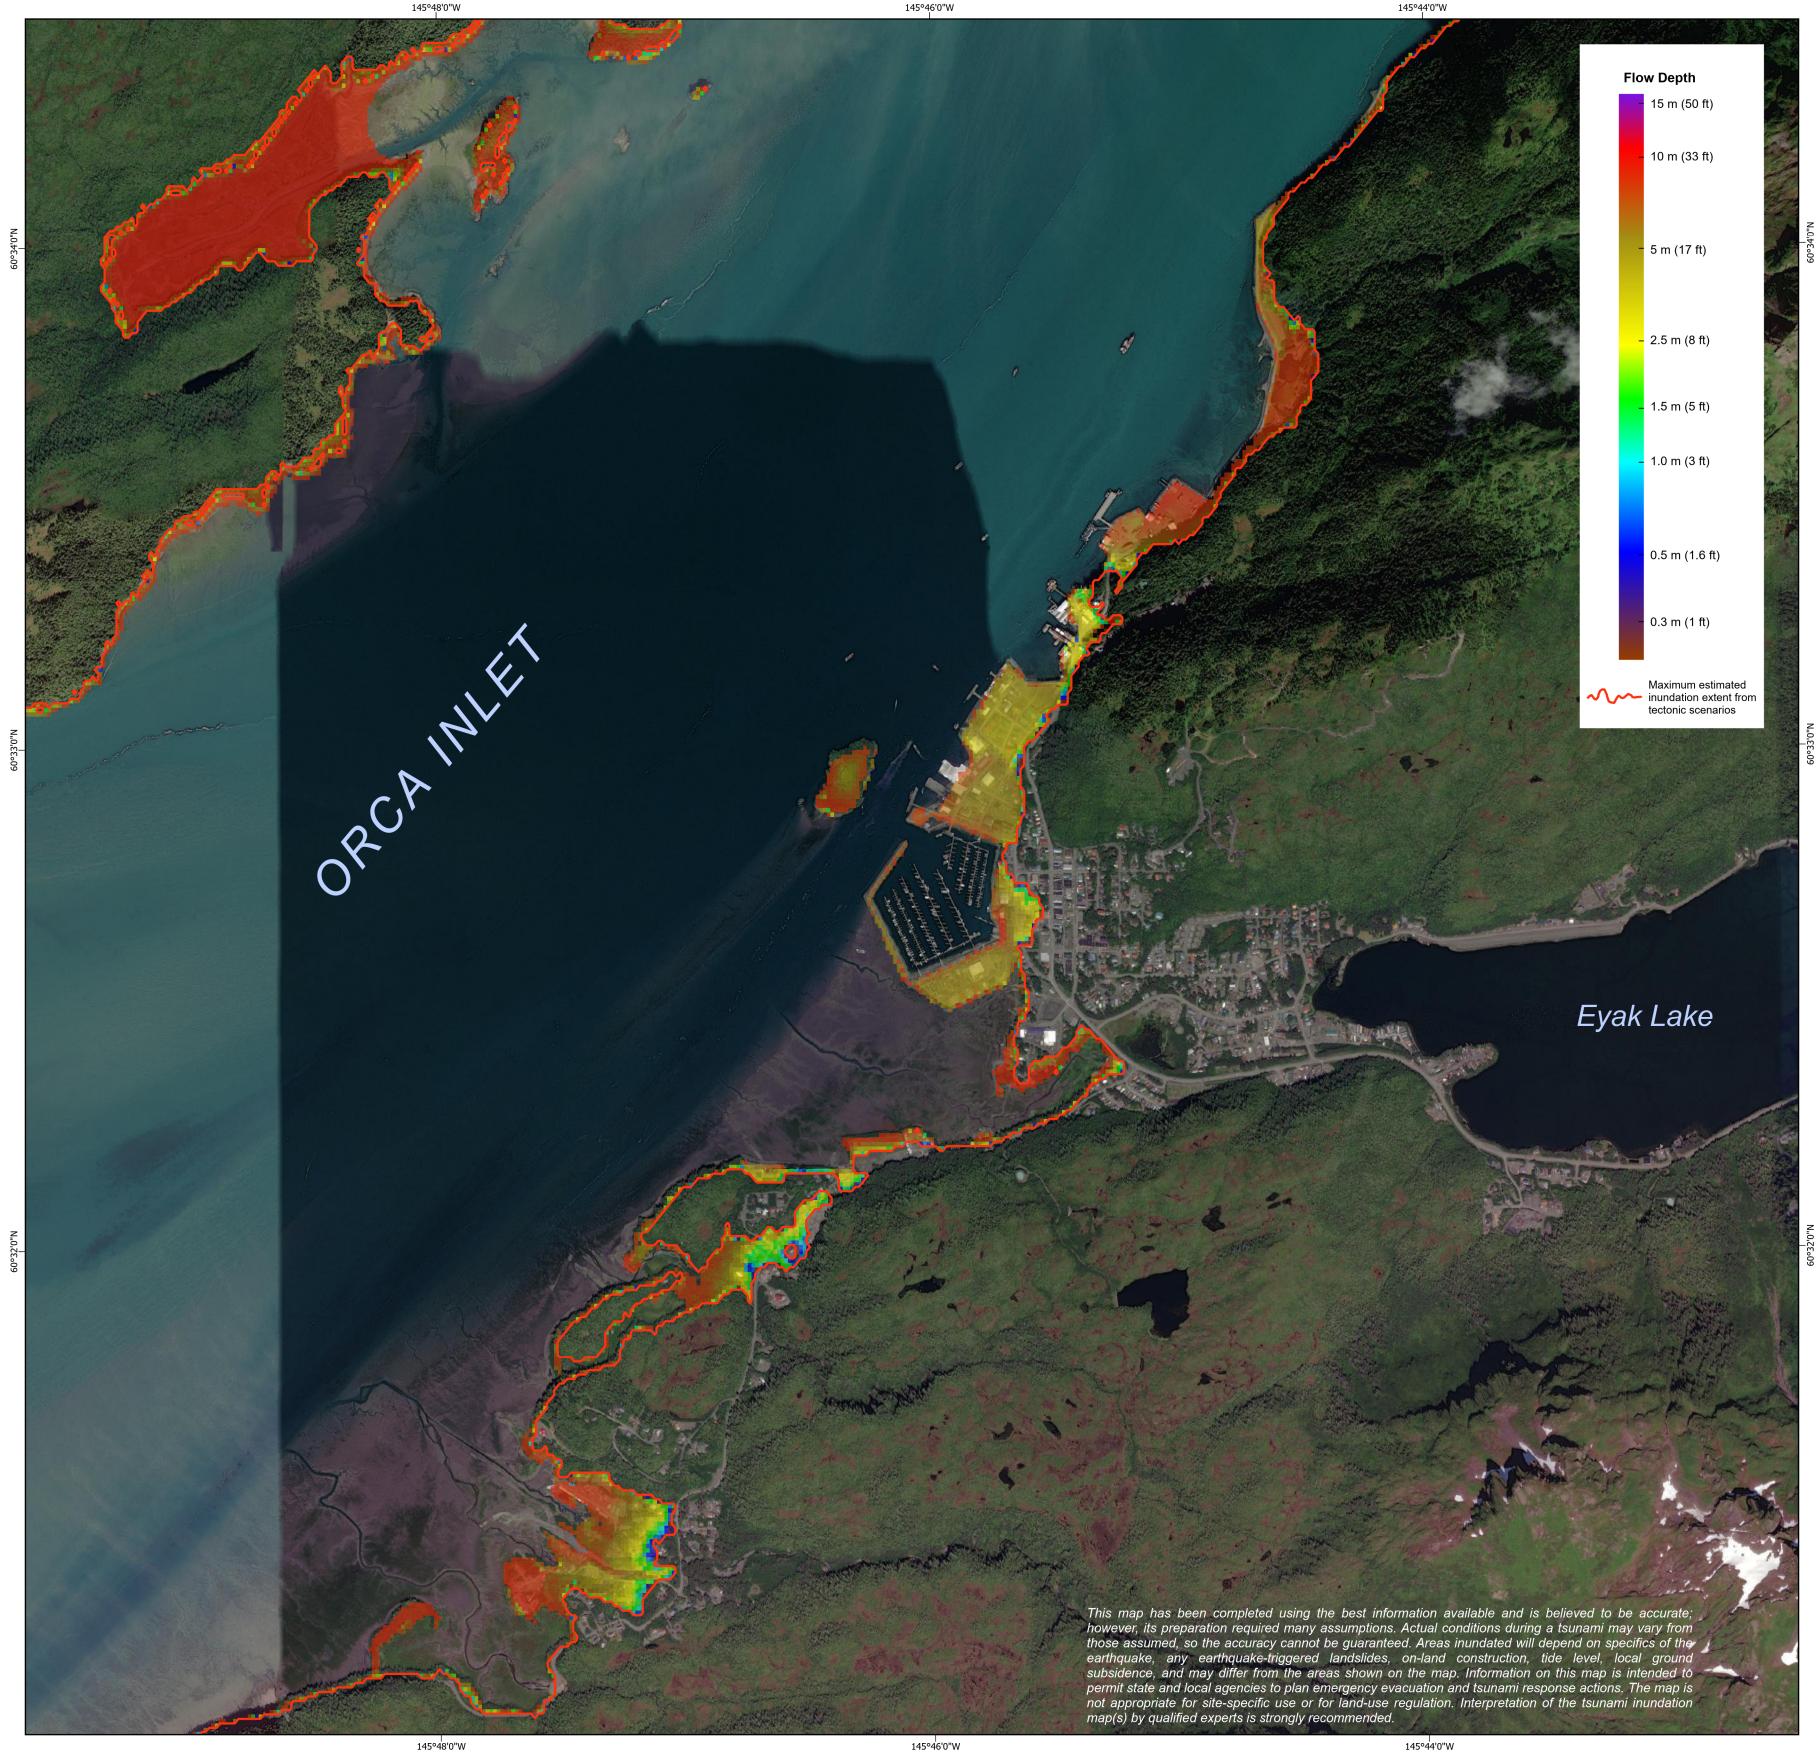
Base map from:
Esri World Imagery
Projection:
Alaska State Plane Zone 3 (Feet)

Datum:North American Datum of 1983
